Manhole Inspection Summary

Manhole # S43E2_011MH

Insp Date: **12/31/07 1:35 PM**

Location Address: **Edwight Ct**

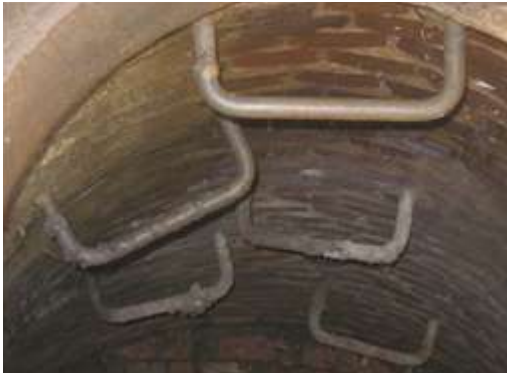
steps

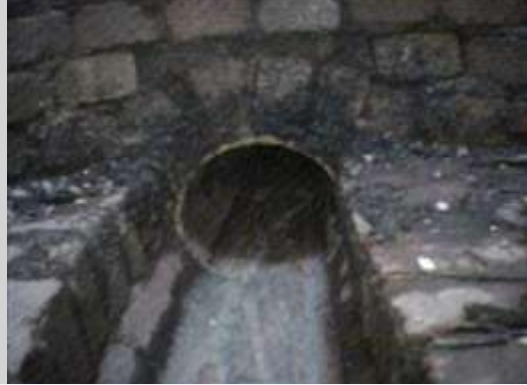
12 O'Clock Outflow

8 in. Circular Gravity Sewer
Pipe Out @ 12 O'Clock

Pipe Height: **9.6** (in.) Rod and Bar (Angled)
Pipe Material: **Clay** ☐ Pipe Lined
Invert Depth: **8.89** (ft.) Flow Characteristics: **Fast**
Deposits: ☒ None ☐ Mud ☐ Sludge ☐ Debris ☐ Grease
Silt Depth: (in.) Deposits Extent:
Infiltration: **None** Pipe Seal Cond: **Sound**

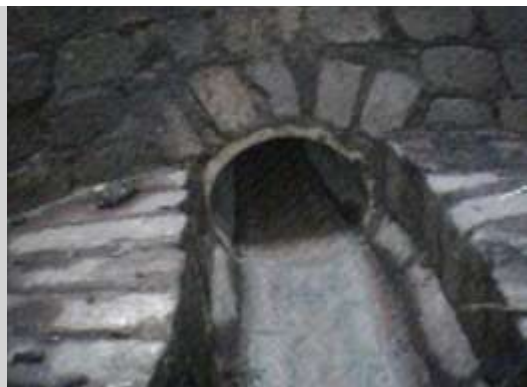
5 O'Clock Inflow

8 in. Circular Gravity Sewer
Pipe In @ 5 O'Clock

Pipe Height: **9.6** (in.) Rod and Bar (Angled)
Pipe Material: **Clay** ☐ Pipe Lined
Invert Depth: **8.68** (ft.) Flow Characteristics: **Fast**
Deposits: ☒ None ☐ Mud ☐ Sludge ☐ Debris ☐ Grease
Silt Depth: (in.) Deposits Extent:
Infiltration: **None** Pipe Seal Cond: **Sound**
